CULTURAL RESOURCES SURVEY

LONG BRANCH LAKE

Macon County, Missouri

HISTORIC ARCHITECTURAL RESOURCES

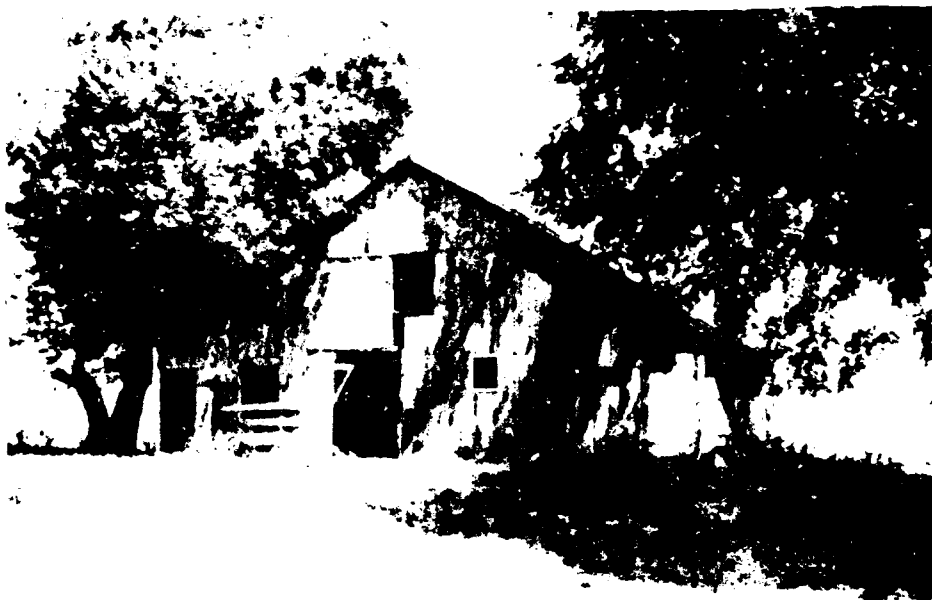
Front of barn

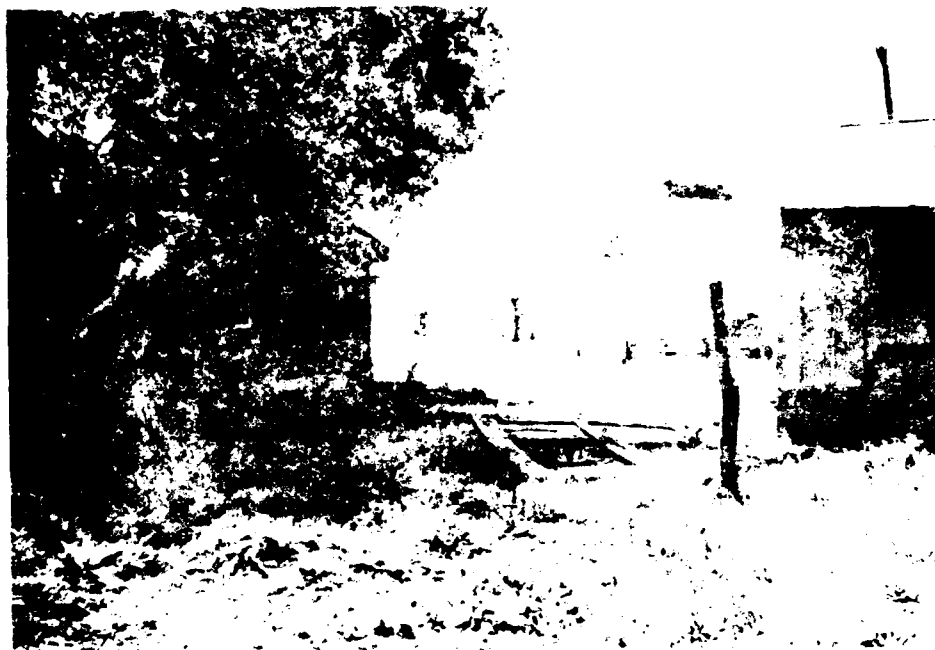
Facing Southwest, view of the barn and garage

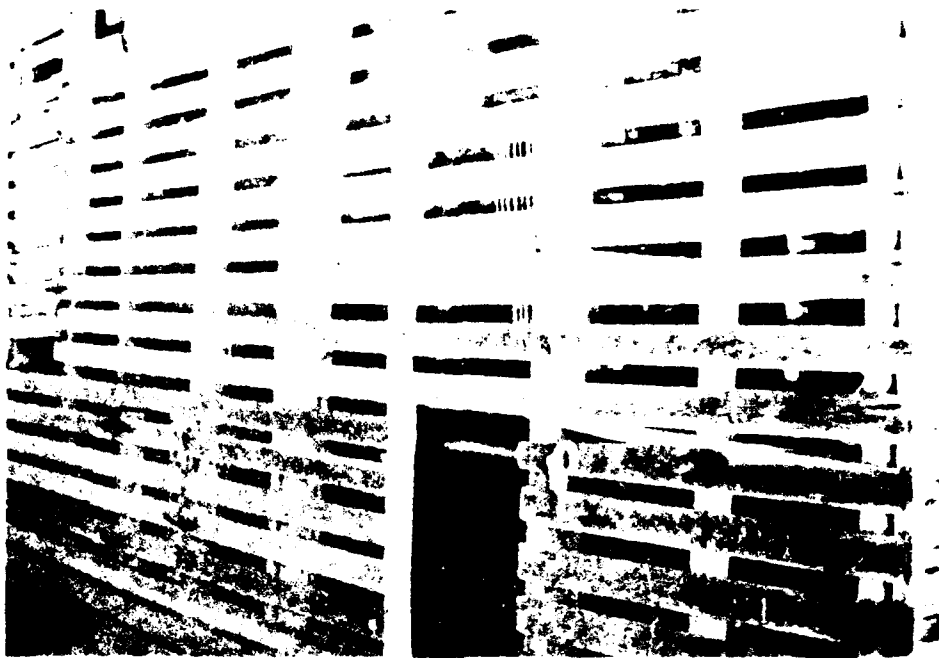
Interior of barn

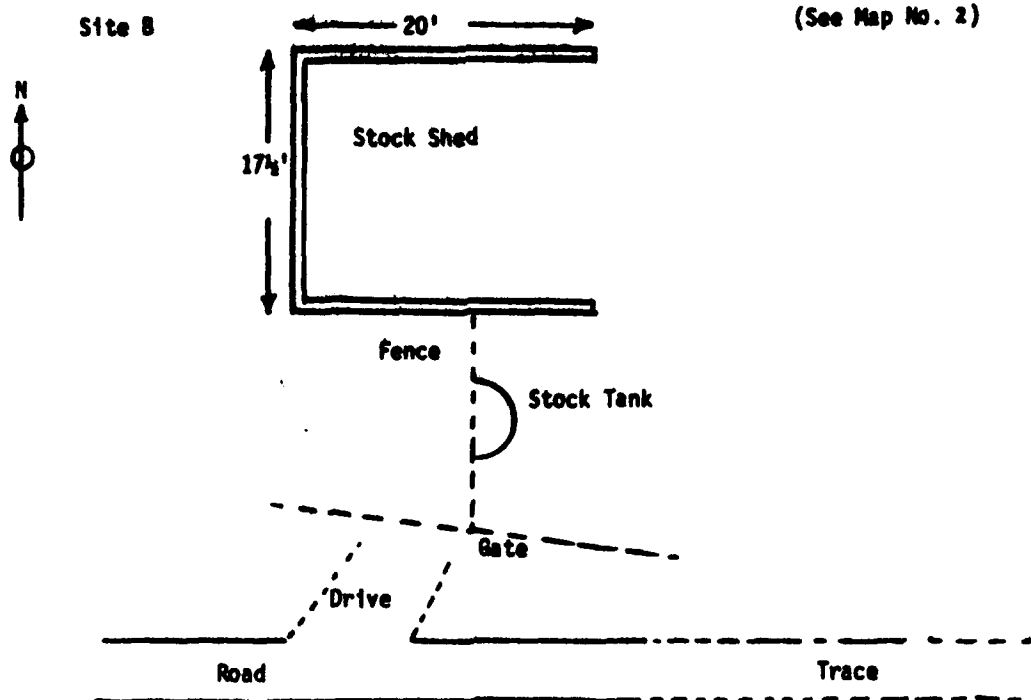
Tract 101-2
Site B

The stock shed and a few fences were all that remained at this site. The fields beyond the shed had been allowed to grow up into tall field grass. The stock tank was battered and probably useless. Fences were in good repair, however, indicating that at the time of inspection, some use was still being made of the fields in that vicinity.

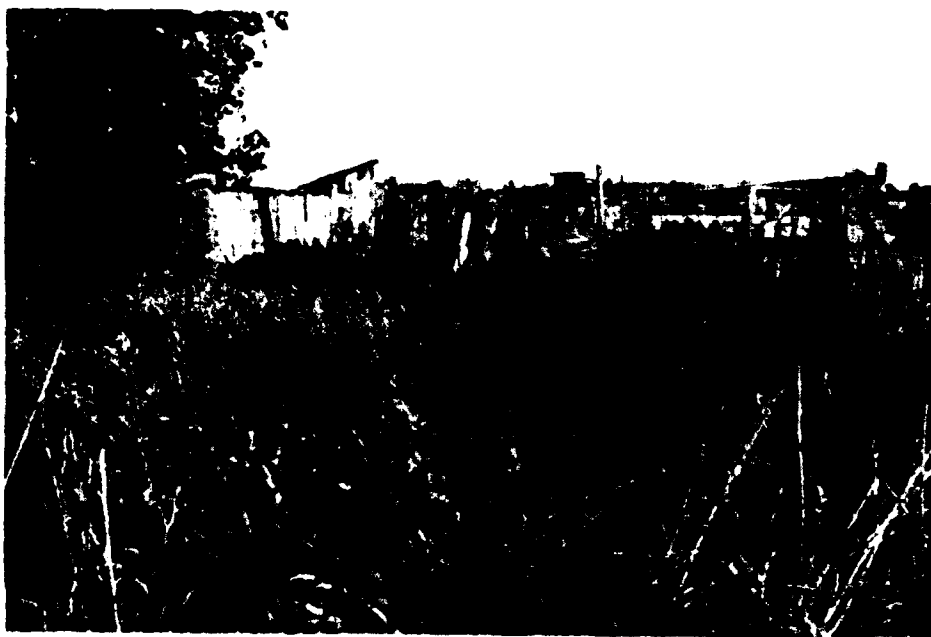
Remains of cow barn, facing north

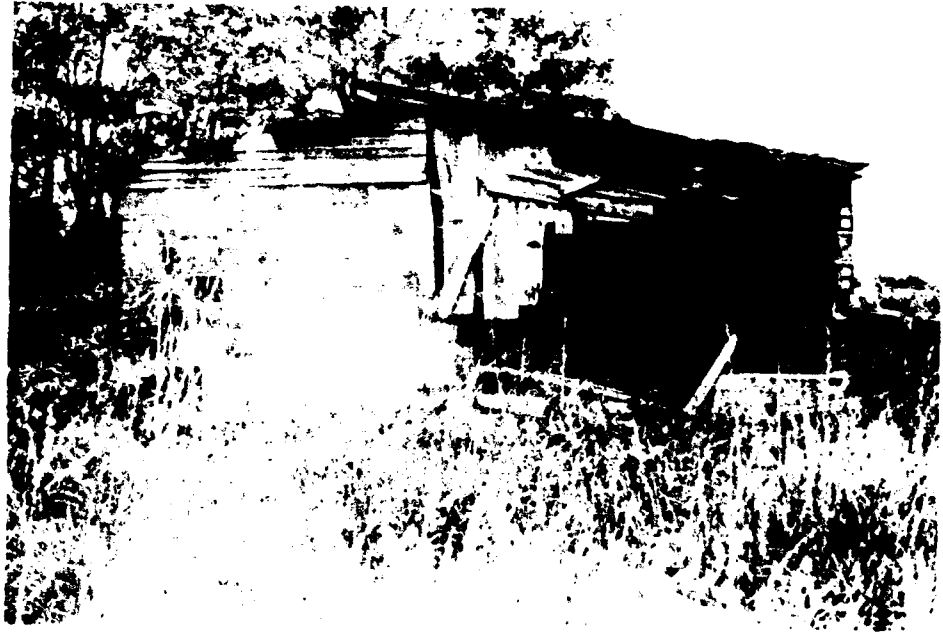
Remains of stable, facing west

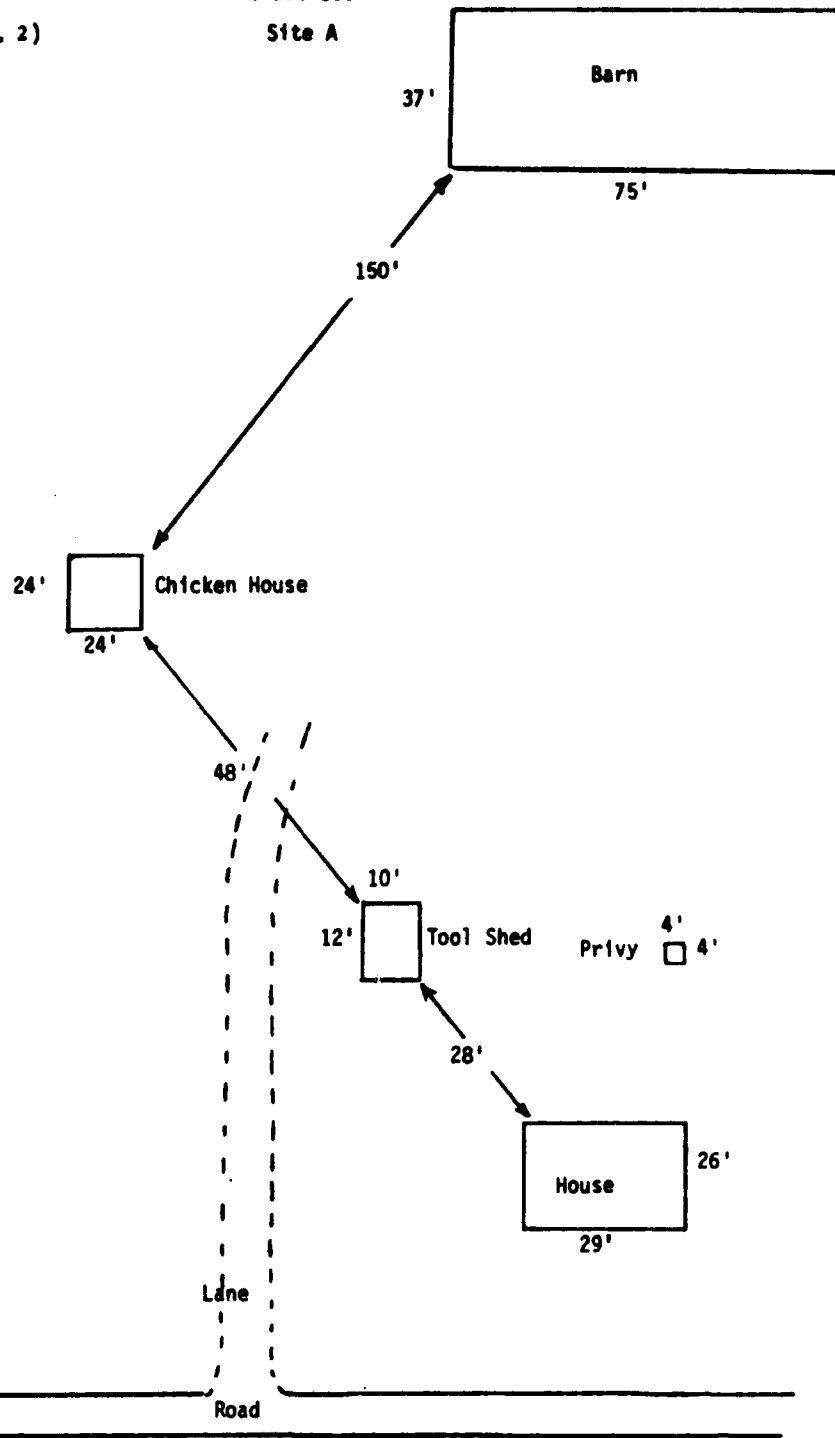
Tract 105
Site A

The house on Tract 105 A had been partially dismantled, and some of its lumber retrieved by the owner. What remained at the time of inspection showed the typical balloon frame construction, with lath and plaster walls.

Evidences of age were shown in the several layers of wallpaper, the newer shingle siding over the older structure, and the re-roofing on the porch.

One porch column of the type commonly found in houses of the 1920s remained as sole evidence of any stylistic pretensions. It was impossible to guess what the roof line might have been but tradition would favor the simple gable roof for houses of this type.

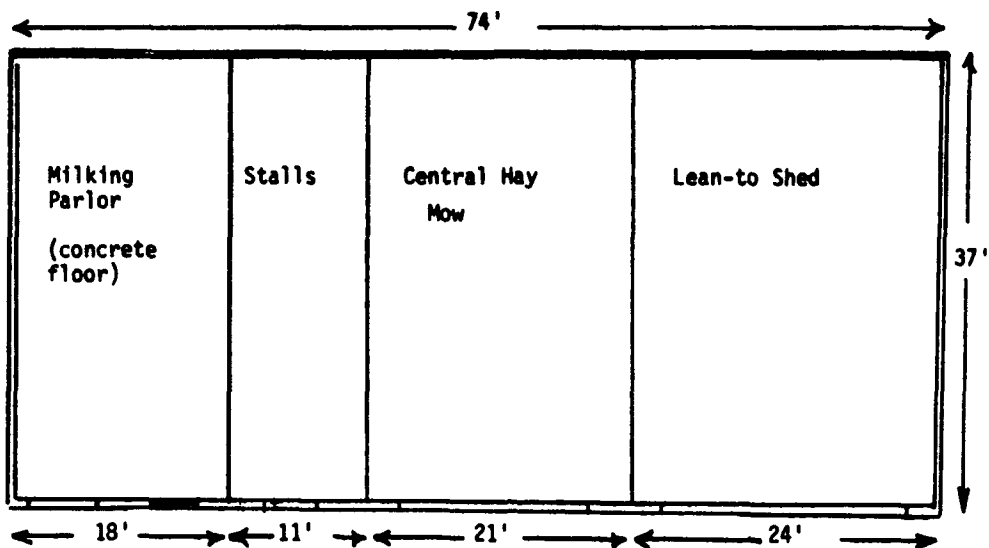
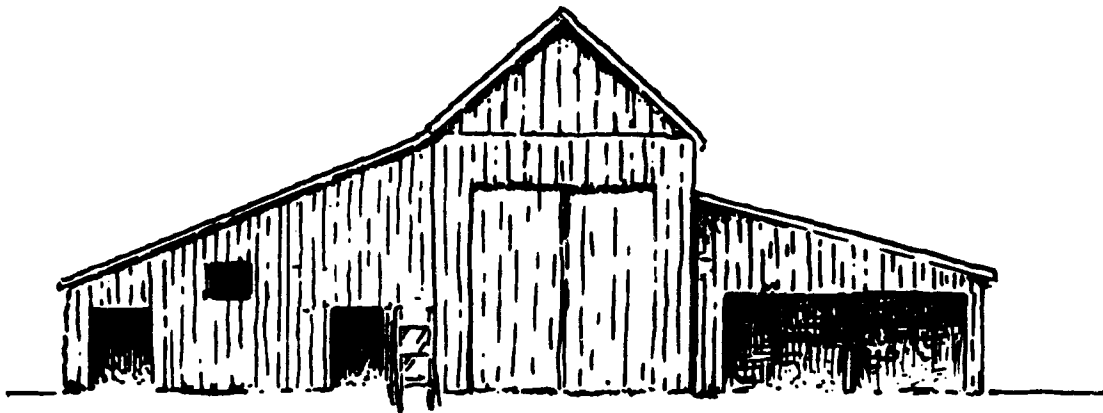
The barn on Tract 105 presented an interesting outline, with its asymmetrical lean-to sections flanking the central area. Largely in a falling-down condition, the barn retained enough of its original shape to reconstruct its appearance as above.

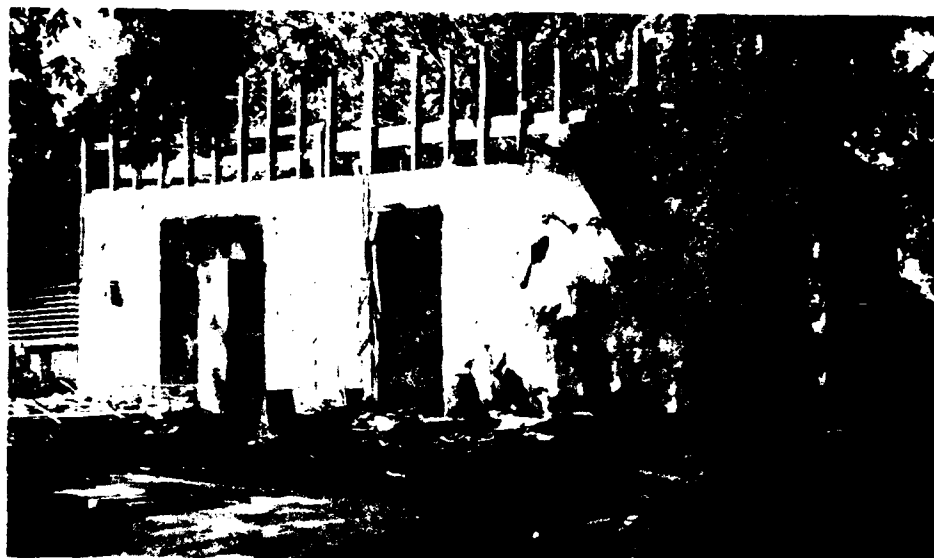
Remains of house, facing Southwest

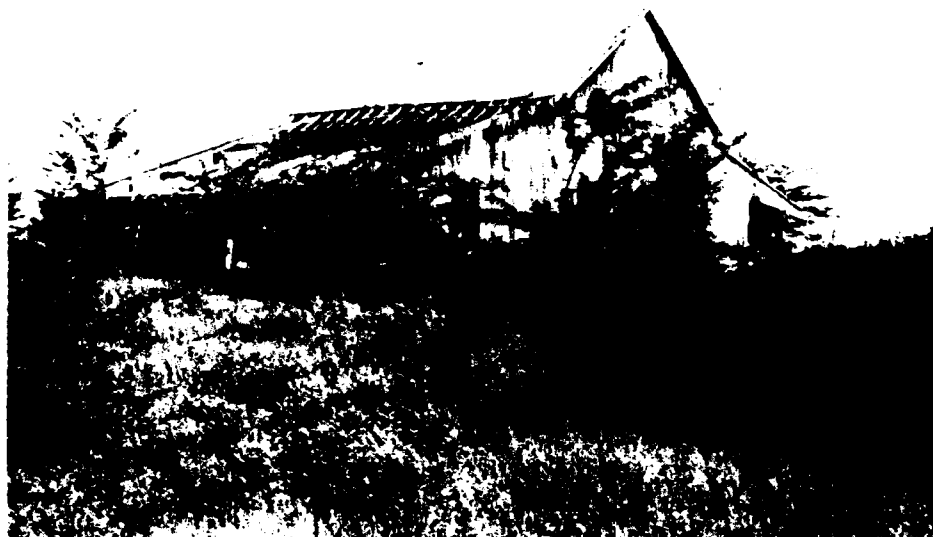
Barn, facing Northwest

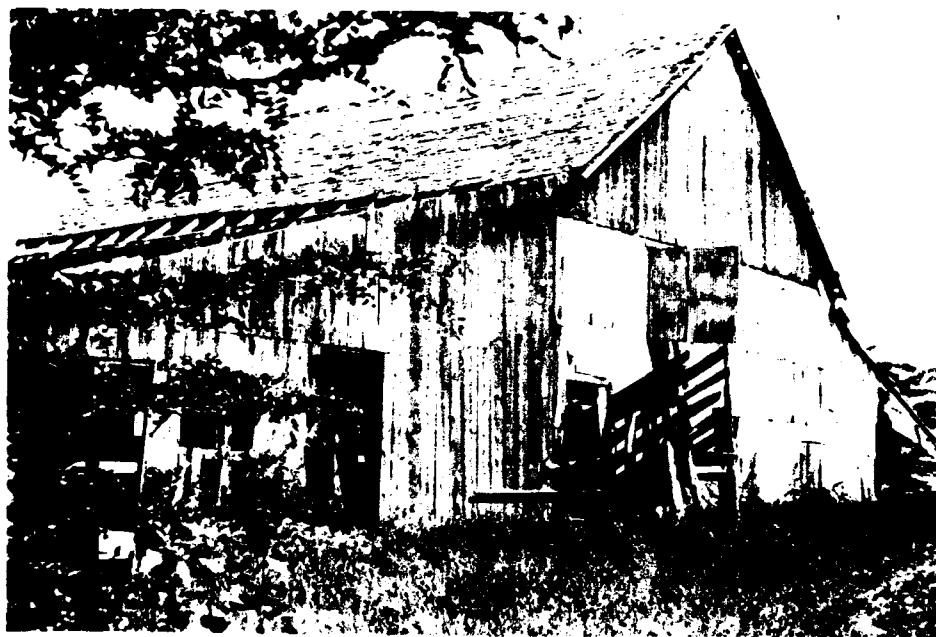
Front of barn, with stock chute

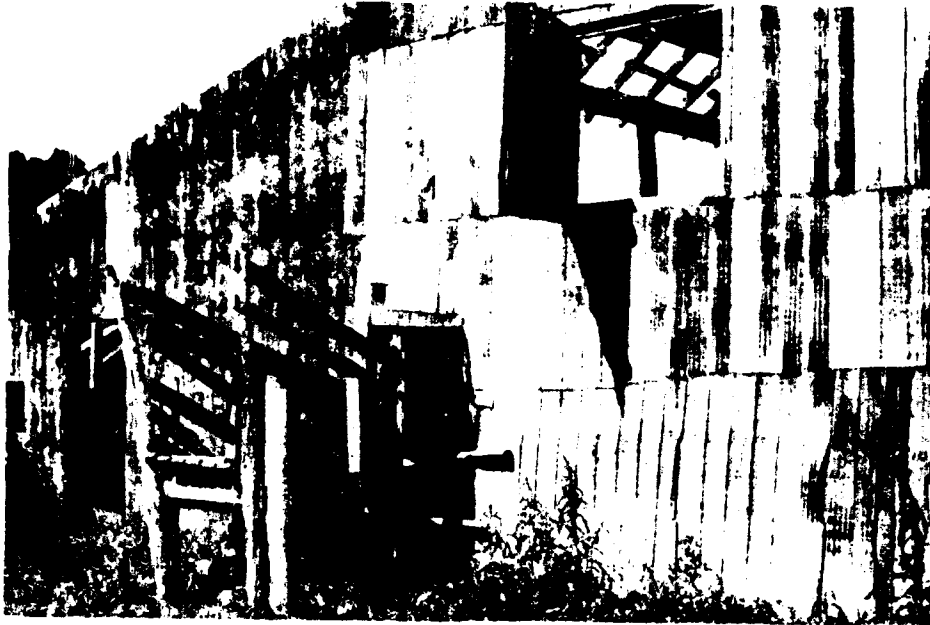
Barn front, showing cattle chute, types of siding

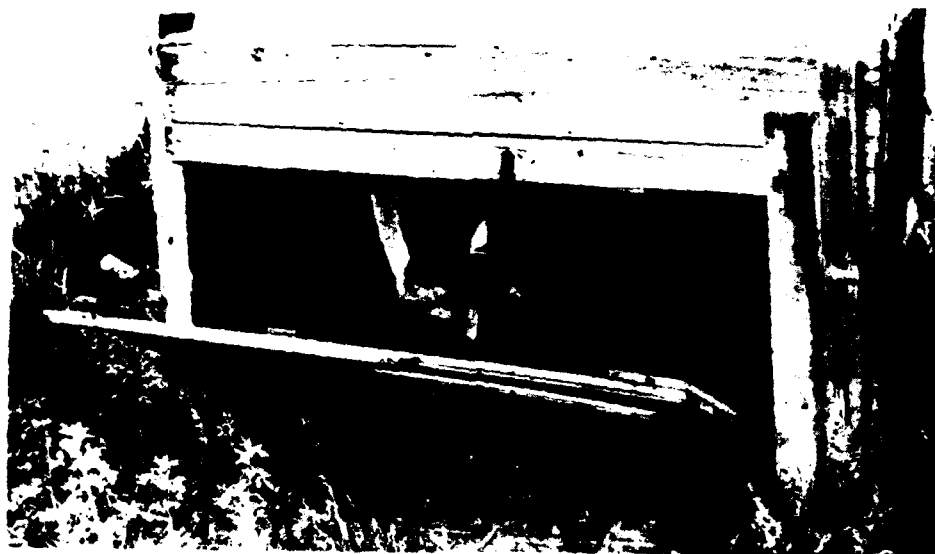
Tipped-over outhouse. Rotate picture
counterclockwise for corrected view

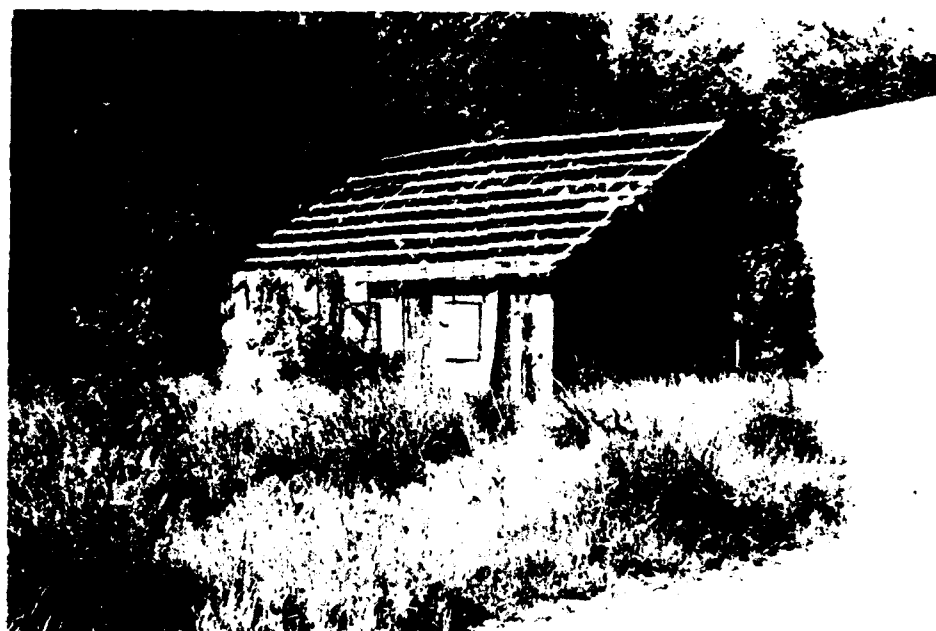
Chickenhouse, viewer facing Southwest

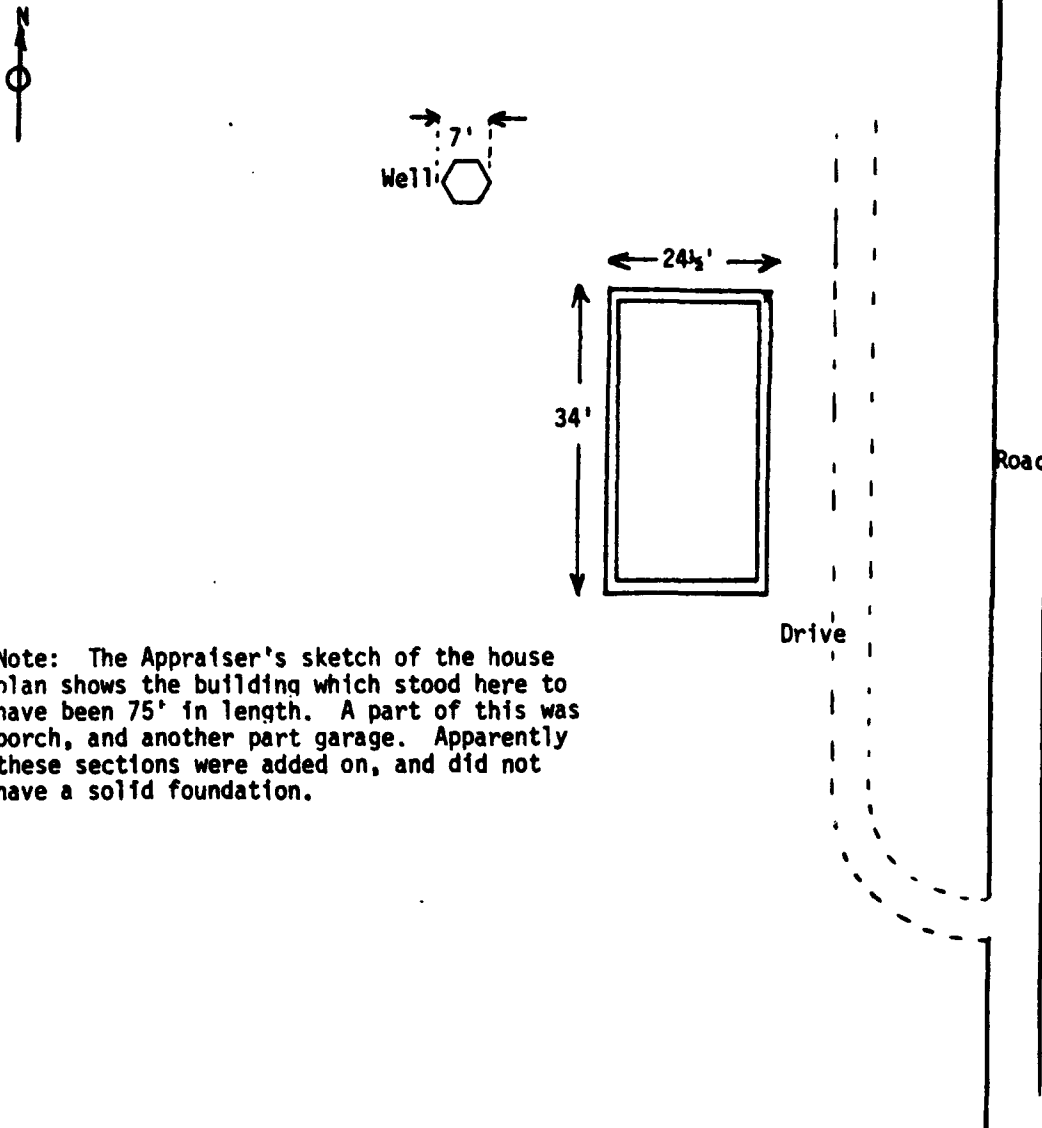
Originally occupied by a three bedroom home, the lot area now has only a foundation where the house once stood. Close to it is a capped well.

Note: The Appraiser's sketch of the house plan shows the building which stood here to have been 75' in length. A part of this was porch, and another part garage. Apparently these sections were added on, and did not have a solid foundation.

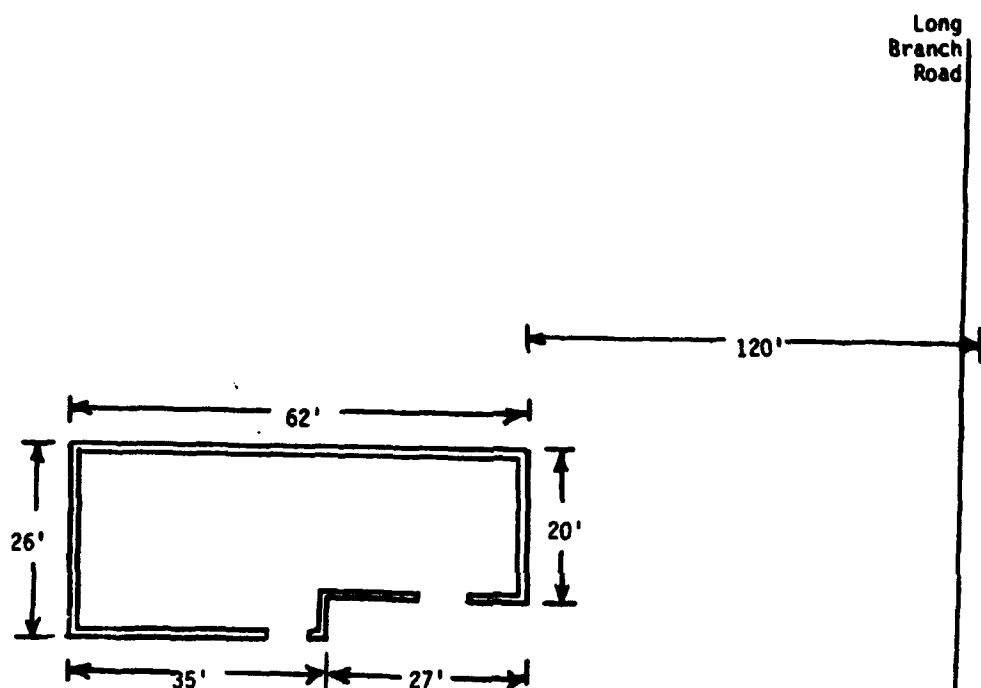
Tract 115
Site A

Tract 115 contained the poured cement foundation and walls of what had been an office building of some sort. There were indistinct evidences of a gravel drive, places where various structures, perhaps mobile units, had been located.

The north side of the cement structure was set into the hillside, with about two feet of it above ground. The south side was open from floor to ceiling height.

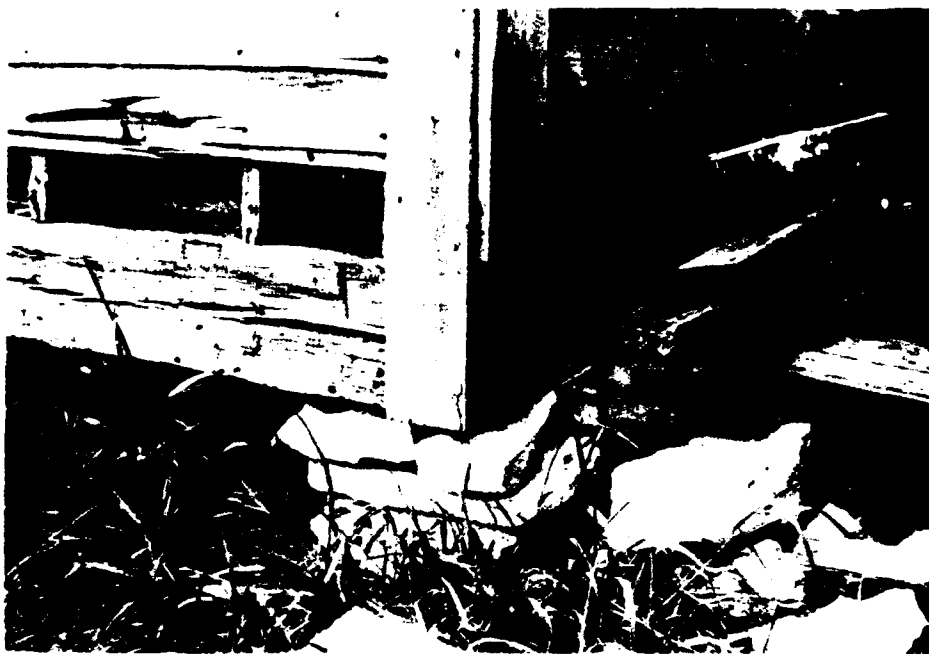
The house rested on 6x6, hand-hewn timbers which had been simply mortised at the ends, and nailed together with square nails. This resulted in some splitting. These timbers rested on slabs of field stone piled up with little or no masonry work done to fit them properly, and no cement to hold the stones in place. Evidences of earlier foundations to the south and west of the house suggest that it may have been moved to its present site.

Detail of Southwest corner of house, showing
field stone corner supports, hand-hewn beams

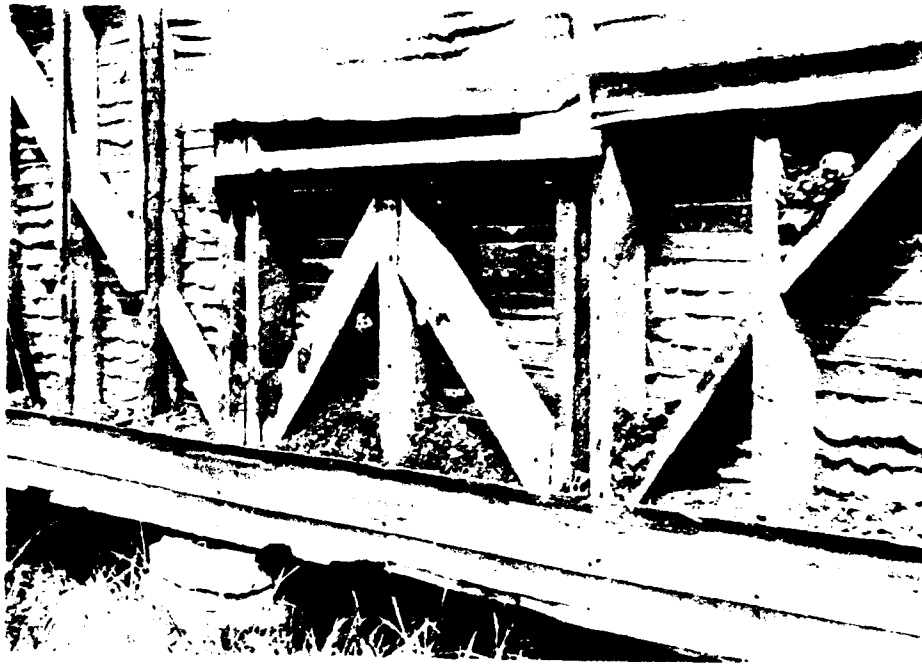
Detail of structure on west side of house

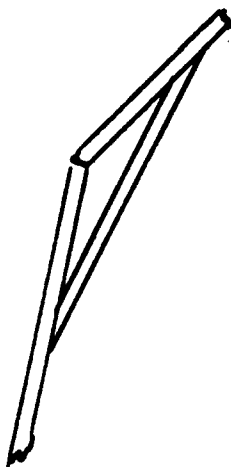
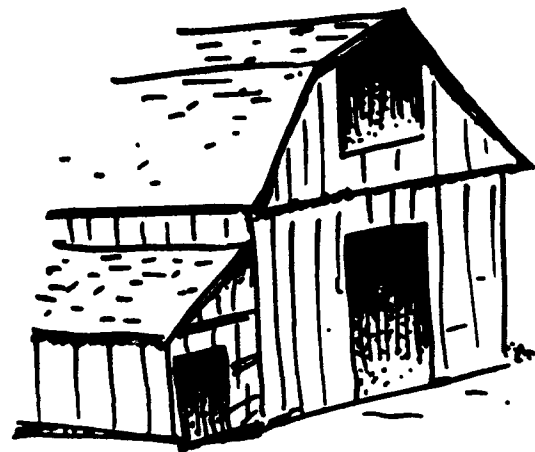
part, caused by

the custom of bracing the gambrel angle with a long spar, as shown at the left. The resultant triangle is so flat as to offer little rigidity, so that the roof tends to sag under the weight of snow, and with age.

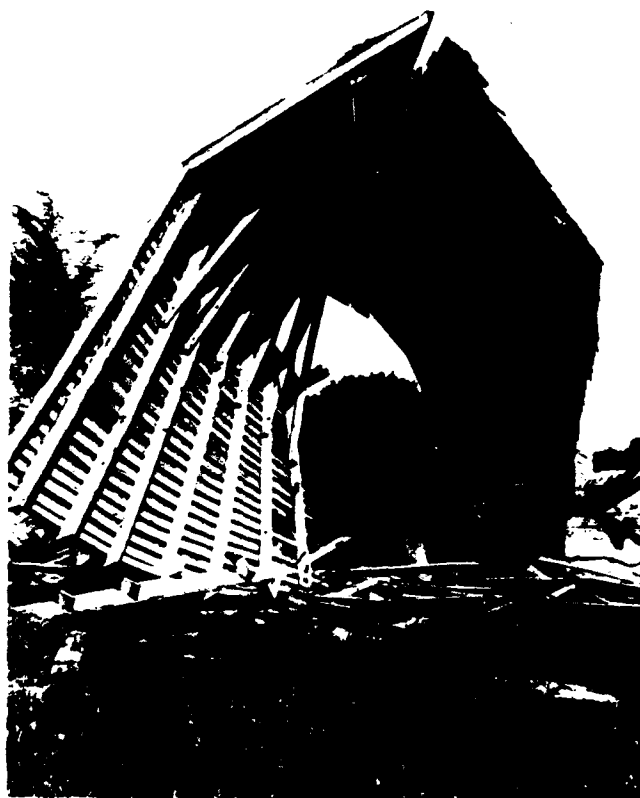
Collapsed barn roof, facing Southwest

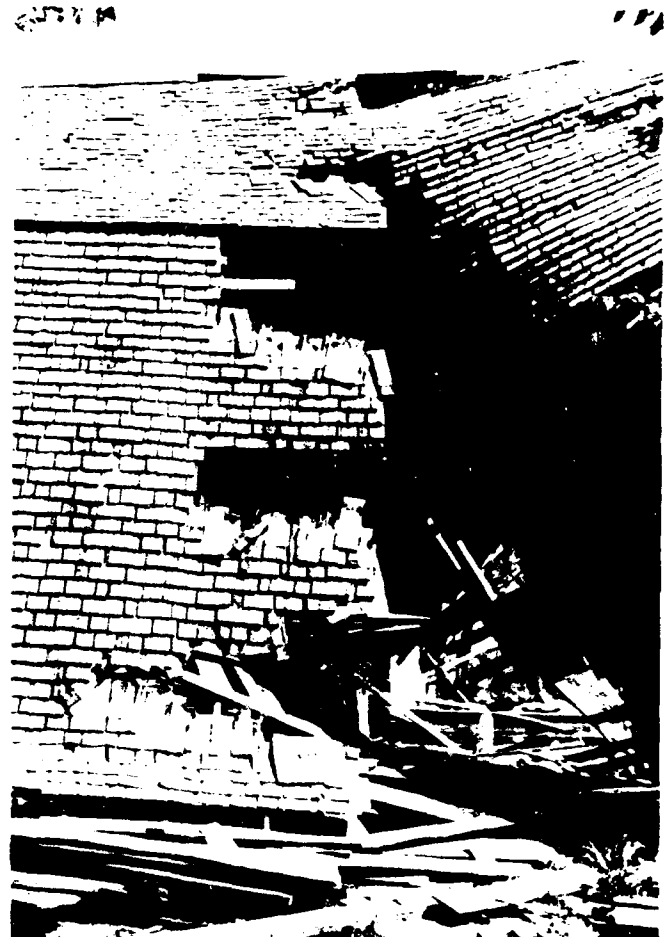
Collapsed
barn roof,
facing South

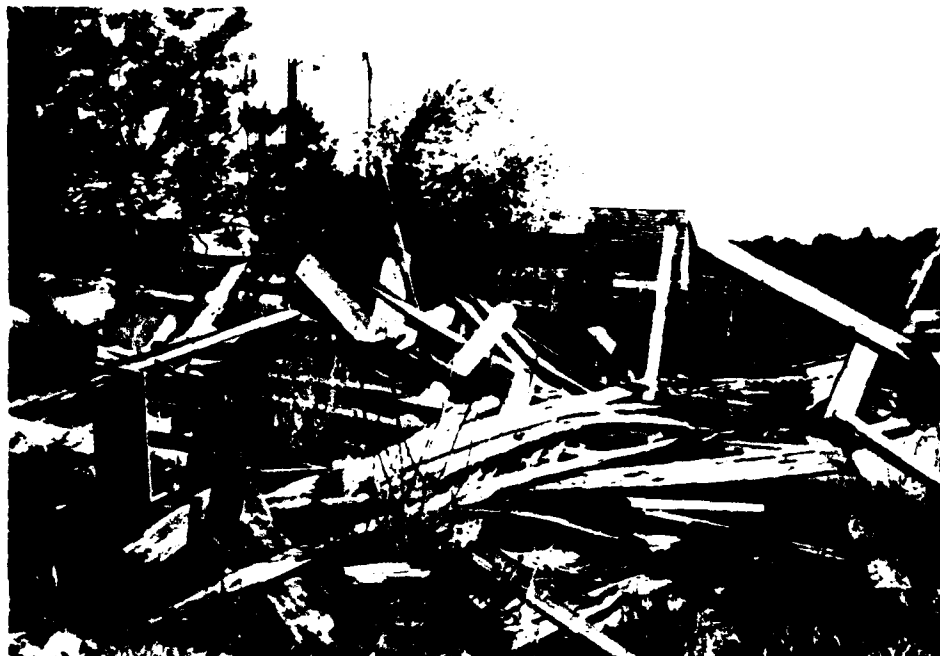
Of the nine structures shown in the appraiser's report, only the two silos and three small, dilapidated sheds remained at the time of inspection.

Facing west, two silos and shed in background.
Shed rubble in foreground

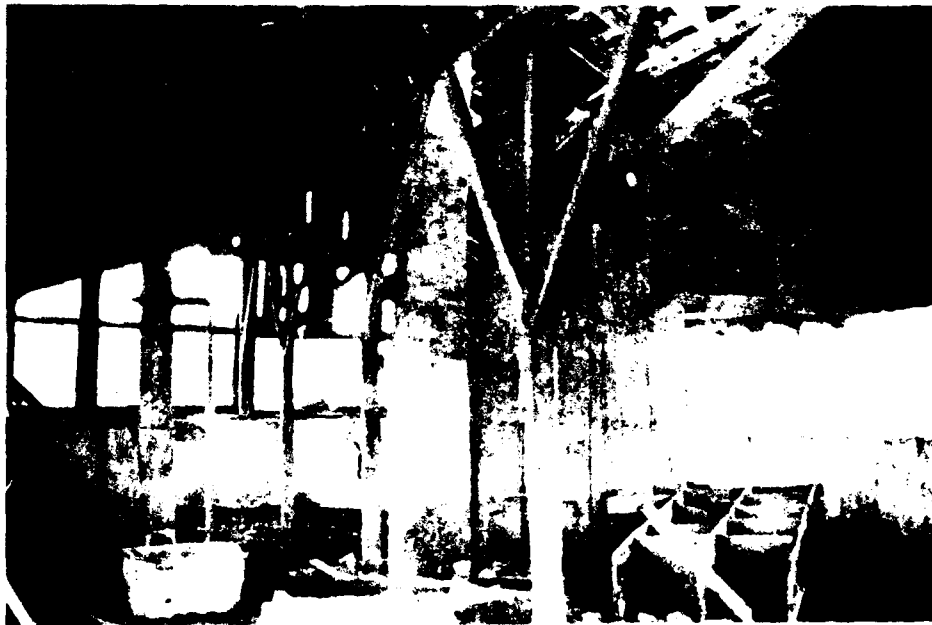
Interior of Chicken House

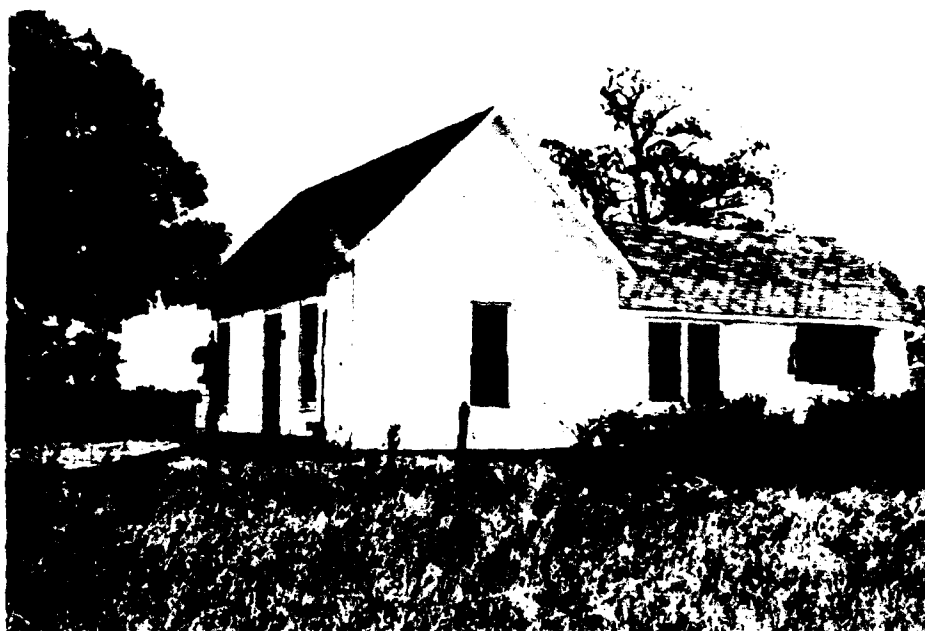
It was in a bad state of repair, with the windows torn out, all fixtures removed, and much of the flooring taken up.

House, viewer facing East-southeast

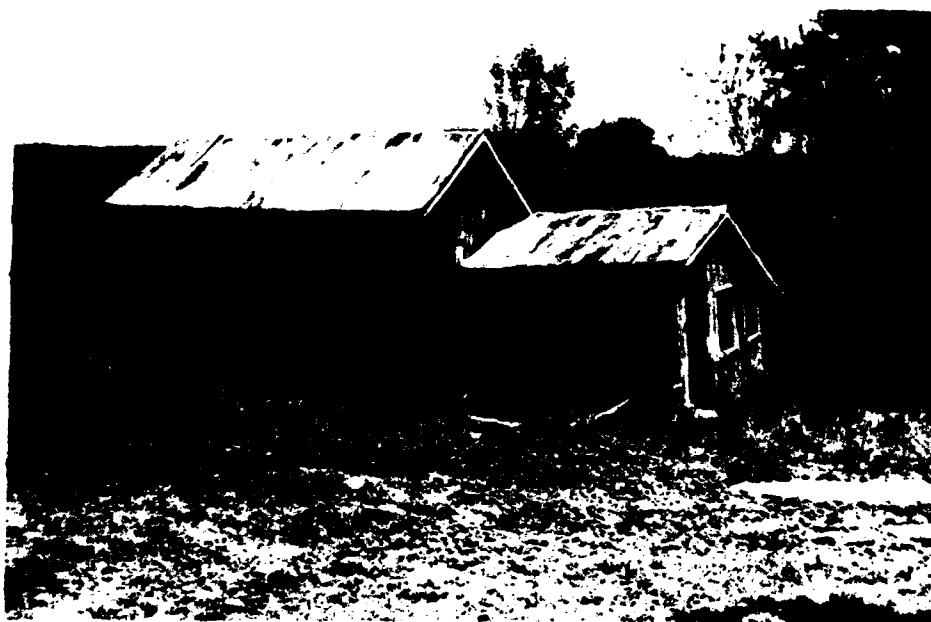
Chicken House, viewer facing East-northeast

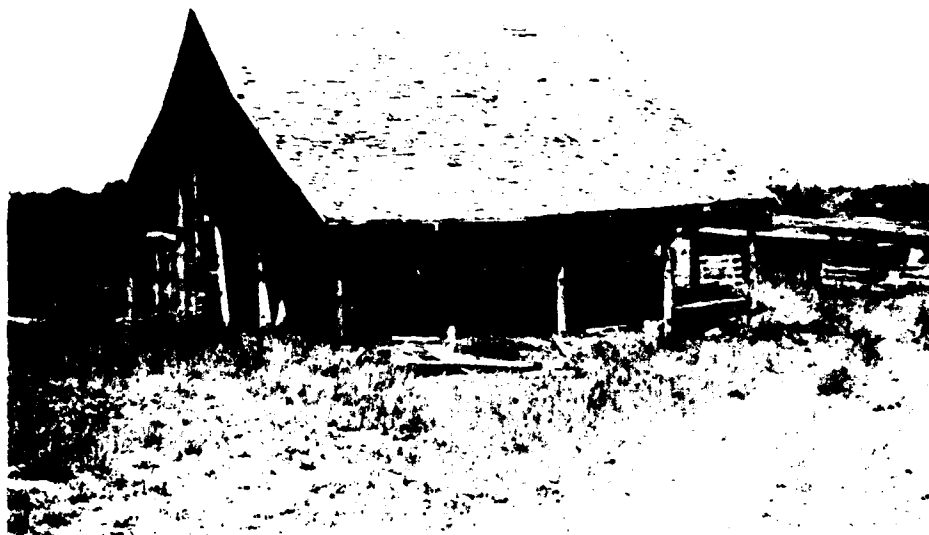
At time of inspection, house was partially torn down, and outbuildings in delapidated condition. Barn had been partially dismantled for the timber in it.

Barn, viewer facing Northeast

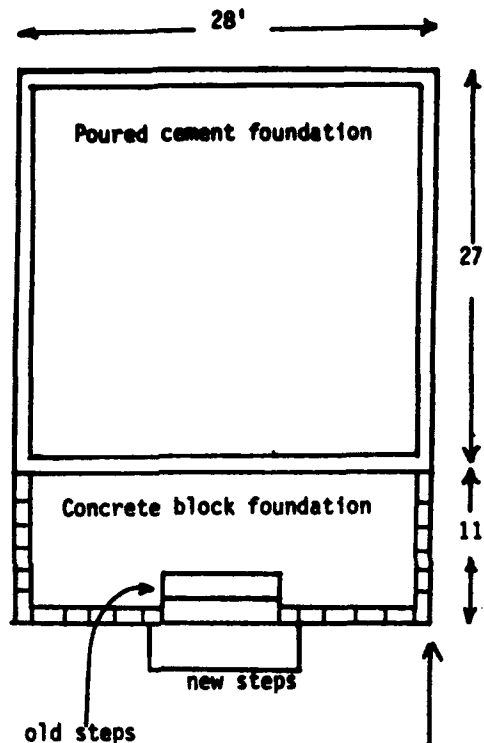
Only the foundation was evident at the time of inspection.

Remains of house foundation

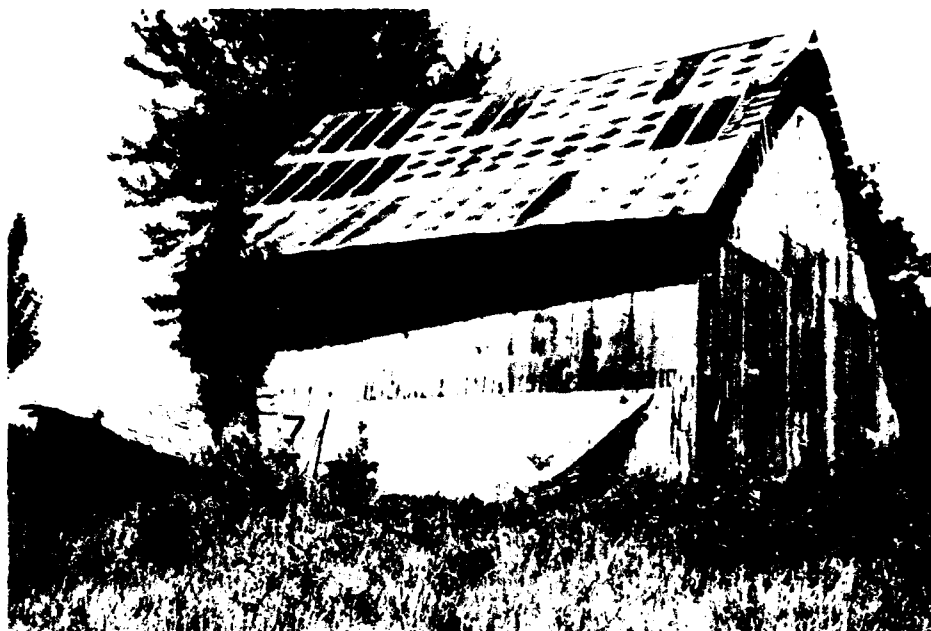
IV. Condition of Site. (If inspected, by whom, when, what was found, address of inspector. Inspected by Mary Jo Polak and Leon Karel, May, 1976
At time of inspection, barn was partially wrecked but still standing.

Barn, viewer facing Northeast

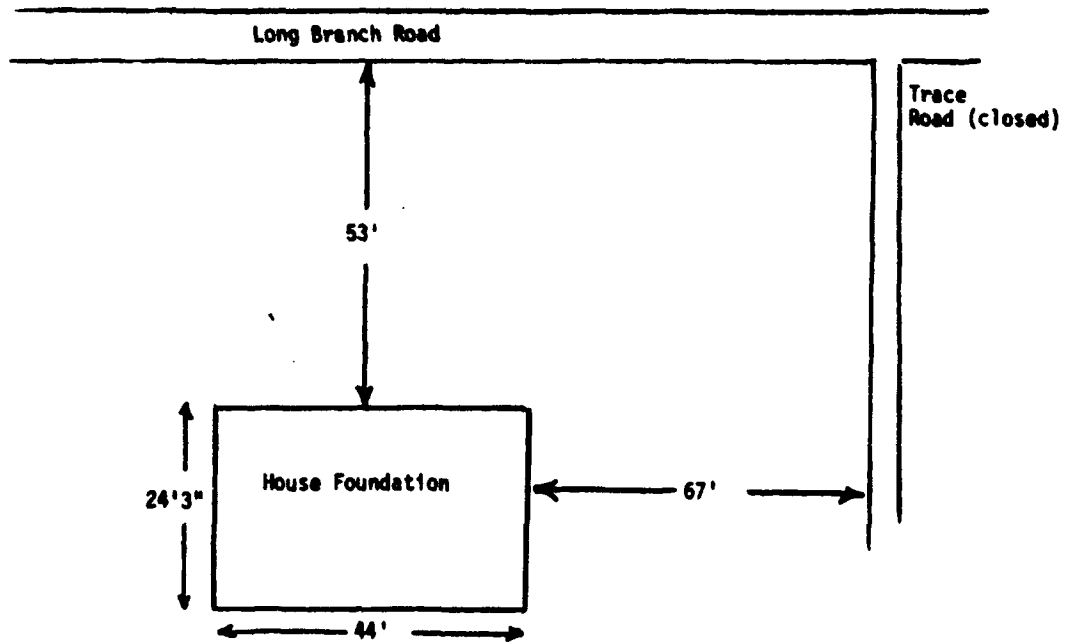
Inspected by Mary Jo Polak and Leon Karel, May, 1976.
At time of inspection, only a house foundation of poured concrete was evident on the site. The house itself had been moved.

Details of House Foundation

This site was marked by the remains of a poured cement foundation and nothing else. Although photos on the appraiser's report indicated a barn nearby, no trace of it could be found.

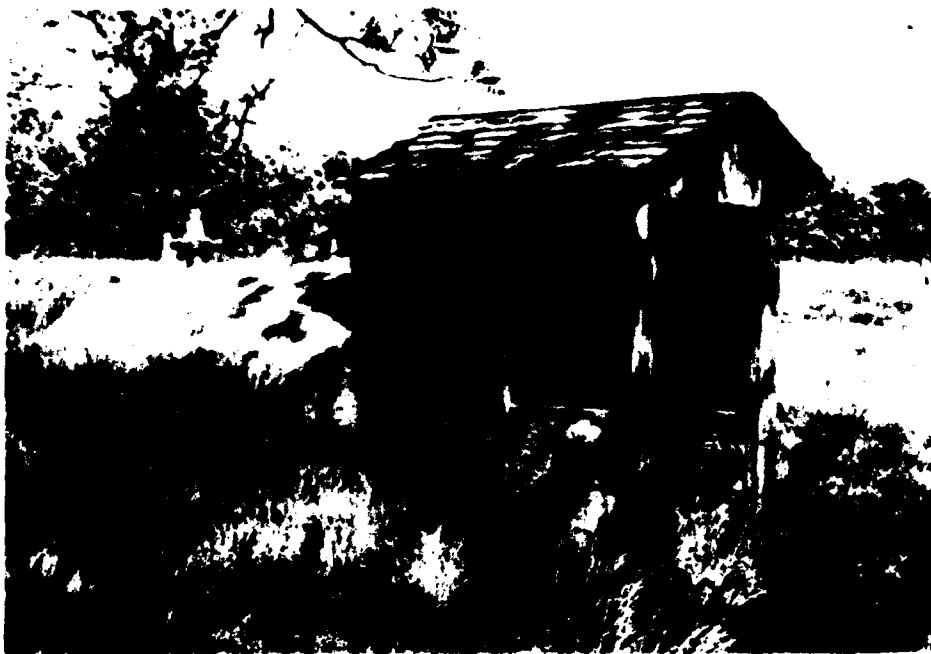
The storm cellar lay slightly lower than the house, with a sharp drop just to the southeast of it. This cellar was the best preserved of the buildings. The cement barrel-vaulted roof was fronted by a native oak entryway (see accompanying photo) still in good repair. Evidences of shelving were found inside, though the interior was choked with debris.

Exterior of storm cellar

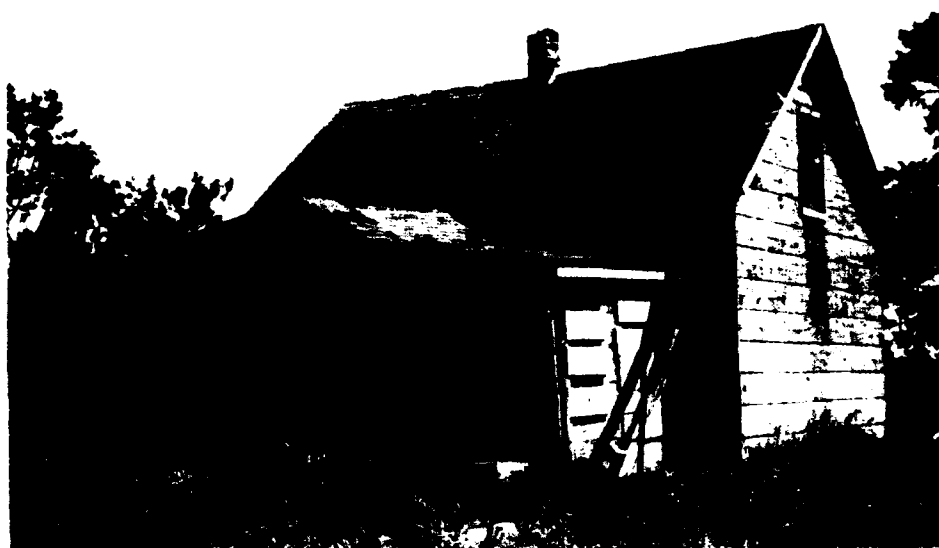
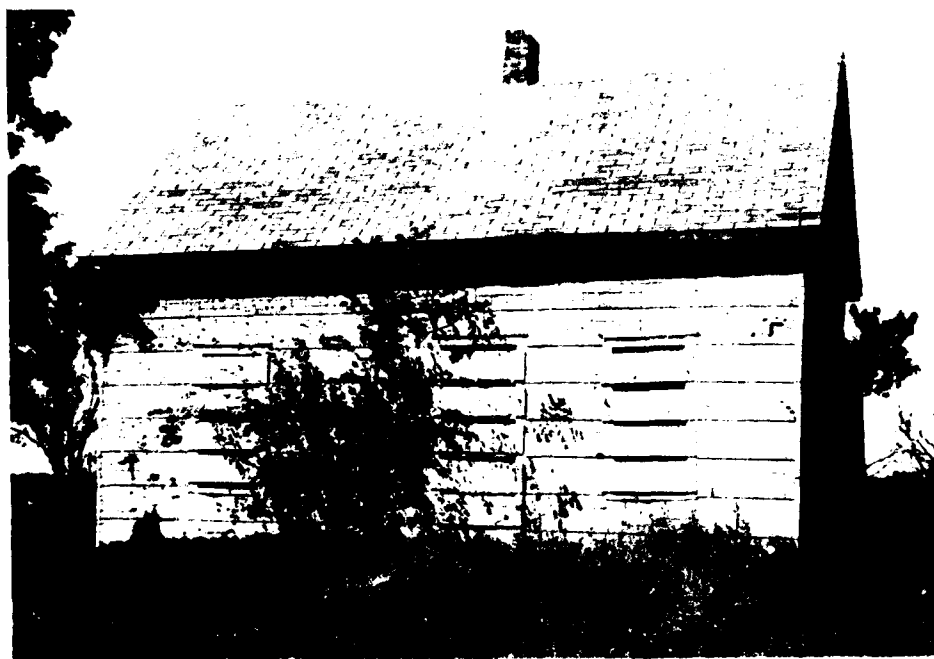
Tract 212 NW-NE-SW-Sec 19-R14W-Twp 58N

At the present time, this last addition has been removed, and the remaining structure is fenced in by barbed wire and warning signs. At the time of inspection, the house had been broken into, and evidences of a drinking party were seen, together with minor vandalism, such as writing on walls, and the like.

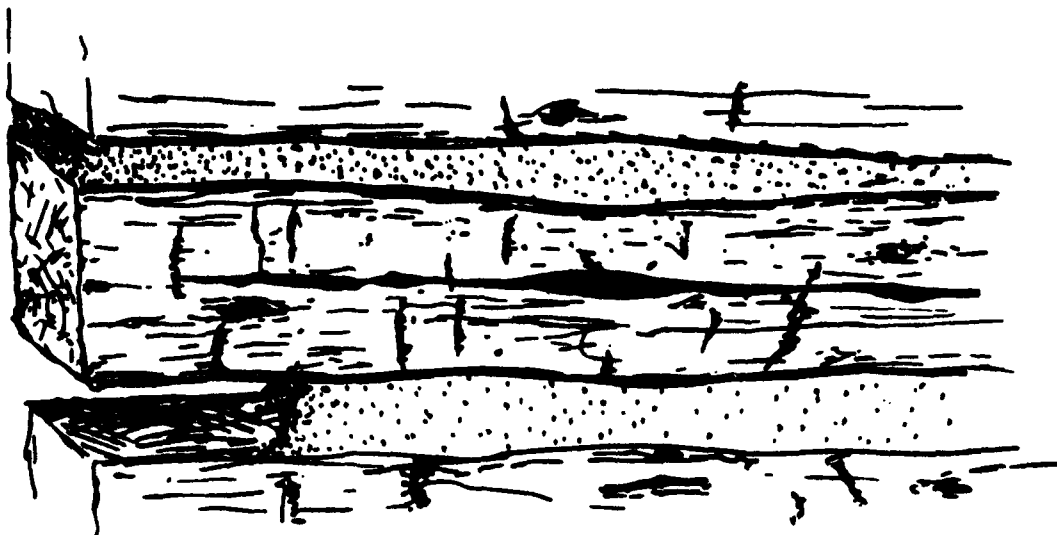
Details of Log Construction

The walls of the cabin were made of hand hewn timbers 8" x 10". The irregular spaces between were filled with plaster originally, and then covered over with cement.

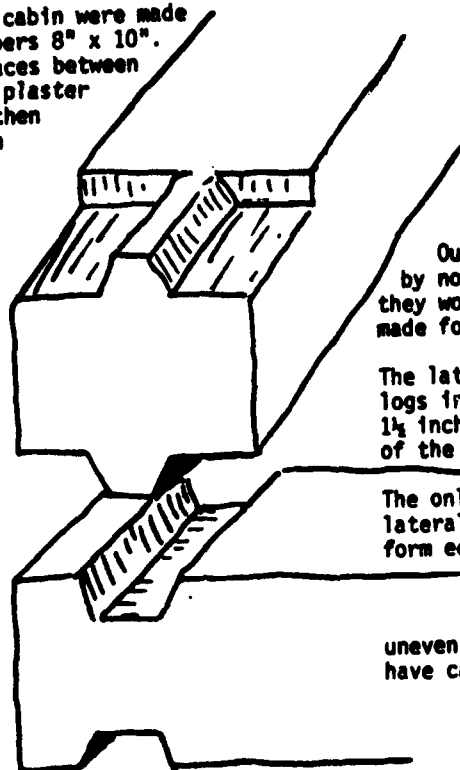
Outside corners were made by notching the logs so that they would interlock. This made for increased stability.

The lateral distance between logs in the walls varied from 1½ inches to 4 inches because of the variations in log sizes.

The only logs that were sawed laterally, so as to form a uniform edge, were those in the topmost course of the wall, where the rafters rested. An uneven log at this point would have caused an uneven roof line.

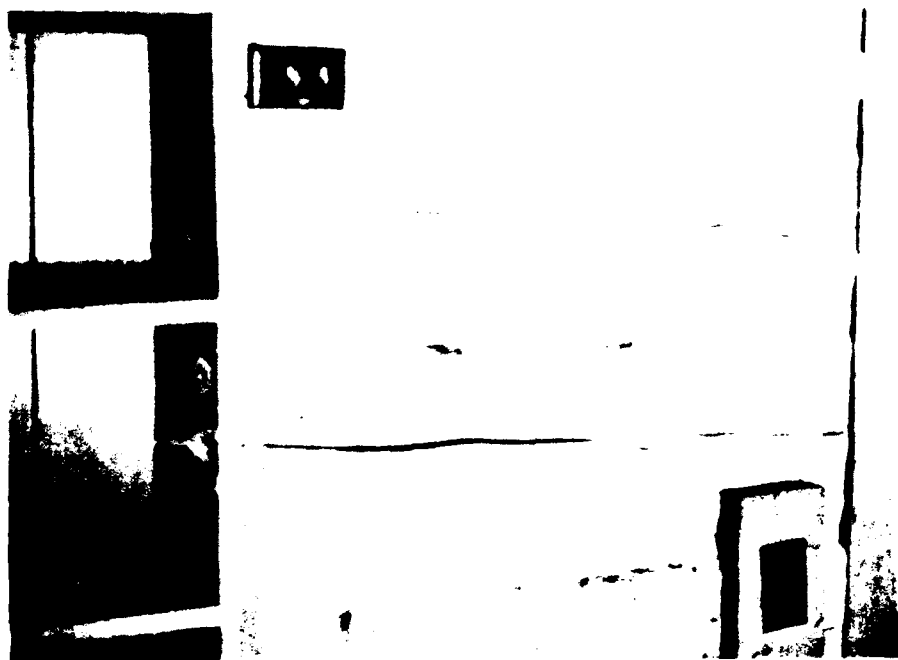
Tract 212 NW-NE-SW-Sec 19-R14W-Twp 58N

Log cabin house, detail of wall, first floor
